LAC BENET DAM

ST. FRANCOIS COUNTY, MISSOURI

MO 30281

# PHASE 1 INSPECTION REPORT NATIONAL DAM SAFETY PROGRAM

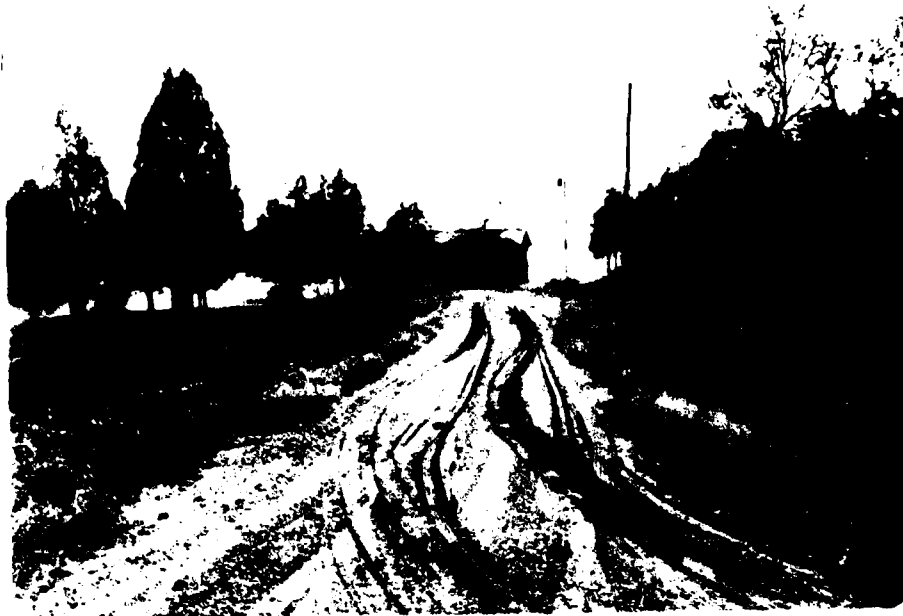
Aerial photographs of the downstream damage zone of this dam were taken in October, 1980. These photographs were used as reference in the field observations of the damage zone which were made during the inspection. Based on the field observations and on the referenced guidelines this dam is in the High Hazard Potential Classification. The estimated damage zone extends approximately one mile downstream of the dam. Within the damage zone are three dwellings and a lake and dam. Photos 17, 18 and 19 show the downstream damage area.

PHOTO NO. 18 - DOWNSTREAM HAZARD JUST ABOVE LOWER LAKE
